Subject:  
Long-Term Operations and Maintenance Annual Report (Soil Remedy)  
South Cavalcade Superfund Site – Concrete Cap  
Houston, Texas

Date:  
July 9, 2013

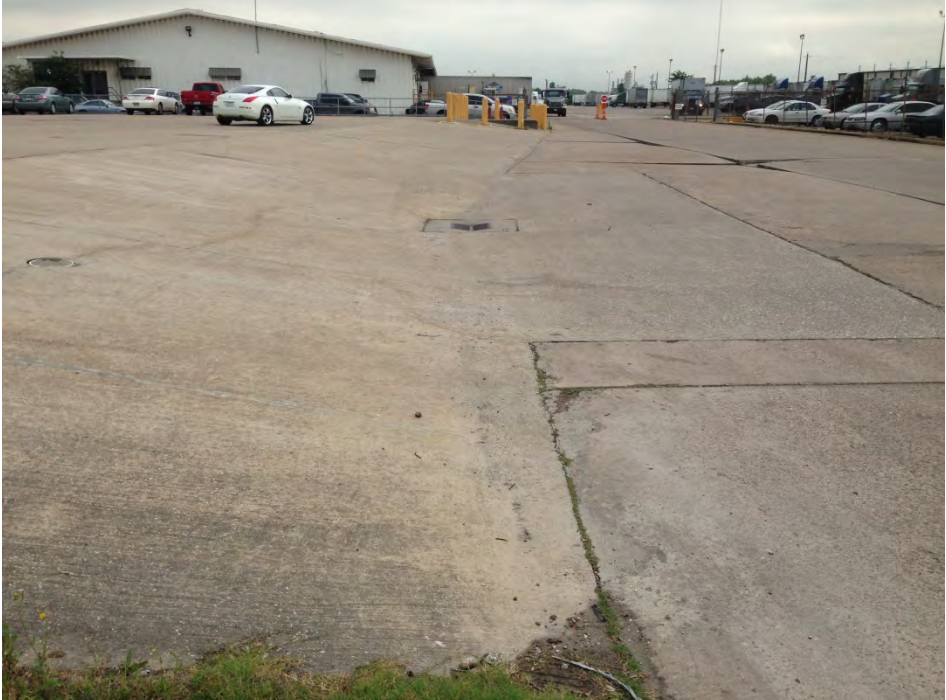
During the inspection, the condition of the cap did not appear to visually differ from the previous years' inspections. The condition of the bollard and removed sign post areas remained unchanged, and minor repairs should still be considered (see Photographs 10 and 14).

<b>SITE PHOTOGRAPH 10</b>	<b>South Cavalcade Site – Beazer East, Inc. Houston, Texas May 22, 2013</b>
<p><b>Direction Photo Taken:</b></p> <p>North-northwest</p> <p><b>Description:</b></p> <p>Southwest Area</p> <p>View of southeast corner location of former sign posts.</p>

- inspect and repair joints where needed
- remove weeds, inspect joints and repair as necessary
- inspect bollard and removed sign post area in Southwest Area, and repair as needed
- inspect and repair large cracks in Southeast Area

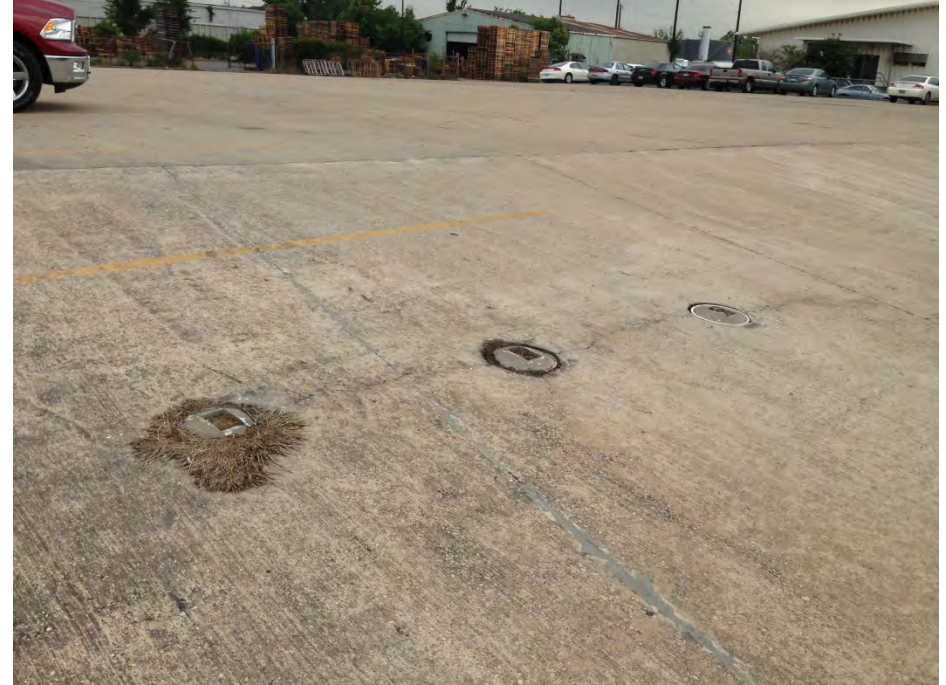
<b>SITE PHOTOGRAPH 11</b>	<b>South Cavalcade Site – Beazer East, Inc. Houston, Texas May 22, 2013</b>
<p><b>Direction Photo Taken:</b></p> <p>North</p> <p><b>Description:</b></p> <p>Southwest Area</p> <p>Typical cracking, same condition as previous years.</p>

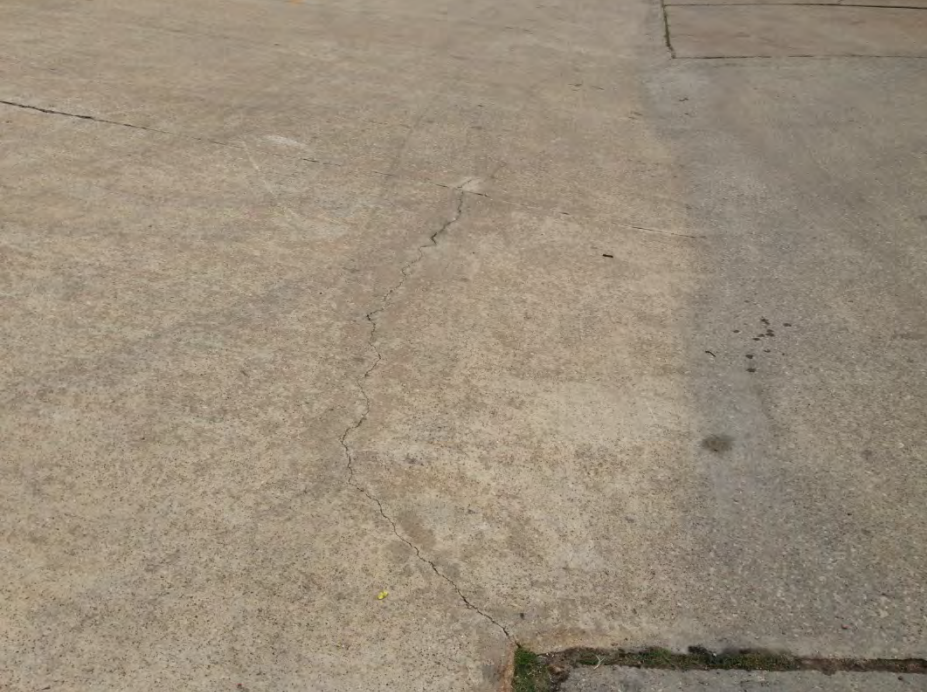
<b>SITE PHOTOGRAPH 12</b>	<b>South Cavalcade Site – Beazer East, Inc. Houston, Texas May 22, 2013</b>
<p><b>Direction Photo Taken:</b></p> <p>West</p> <p><b>Description:</b></p> <p>Southwest Area</p> <p>Typical joint. Same condition as previous years.</p>

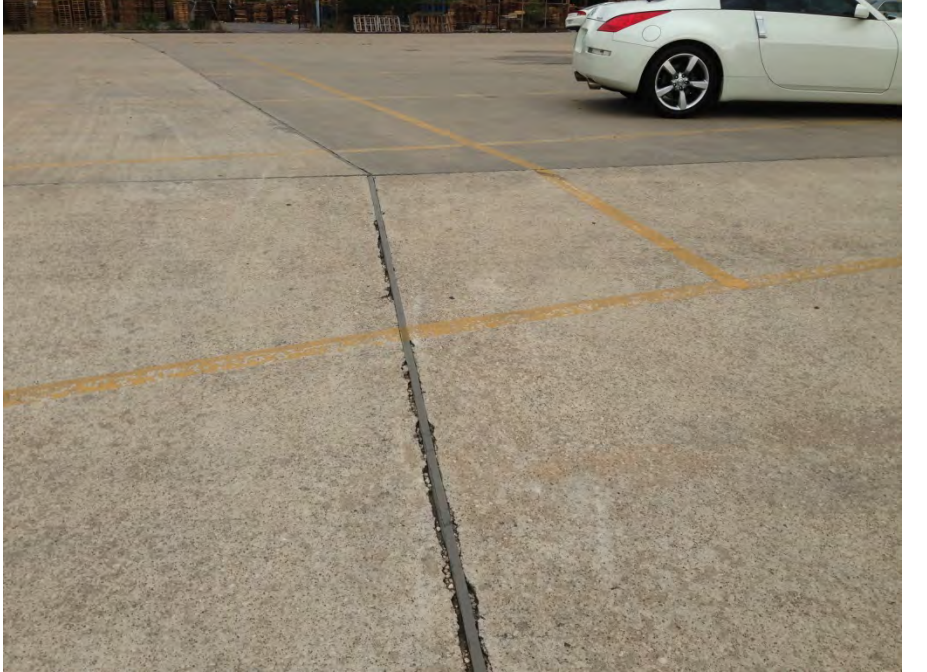
<b>SITE PHOTOGRAPH 13</b>	<b>South Cavalcade Site – Beazer East, Inc. Houston, Texas May 22, 2013</b>
<p><b>Direction Photo Taken:</b></p> <p>West</p> <p><b>Description:</b></p> <p>Southwest Area</p> <p>View of bollards and manhole. Same condition as previous years.</p>

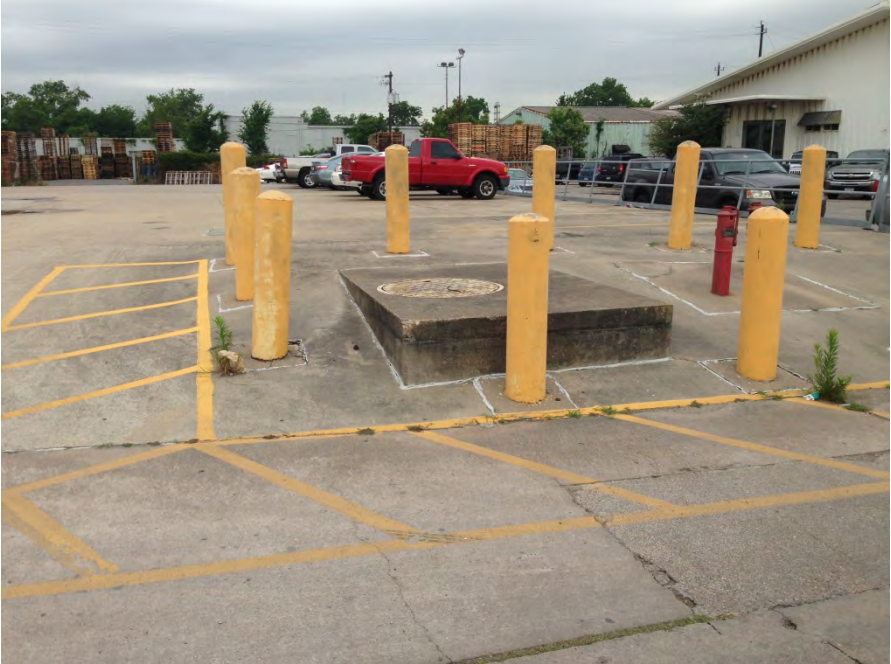
The joint systems are intact and functioning as designed. The previous Long-Term Operations and Maintenance Annual Reports indicated that a bollard location in the Southwest Area is slightly displaced and minor repairs should be considered. The previous reports also noted that locations of removed sign posts in the Southwest Area are shifting and producing gaps that may require recaulking. Previous reports also noted that cracking of the concrete in the Southeast Area is starting to advance requiring continued observation. Note that the above identified areas have not changed from the previous years and still satisfactorily perform the function of a dermal barrier.

<b>SITE PHOTOGRAPH 14</b>	<b>South Cavalcade Site – Beazer East, Inc. Houston, Texas May 22, 2013</b>
<p><b>Direction Photo Taken:</b></p> <p>West</p> <p><b>Description:</b></p> <p>Southwest Area</p> <p>View of displaced bollard. Same condition as previous years.</p>

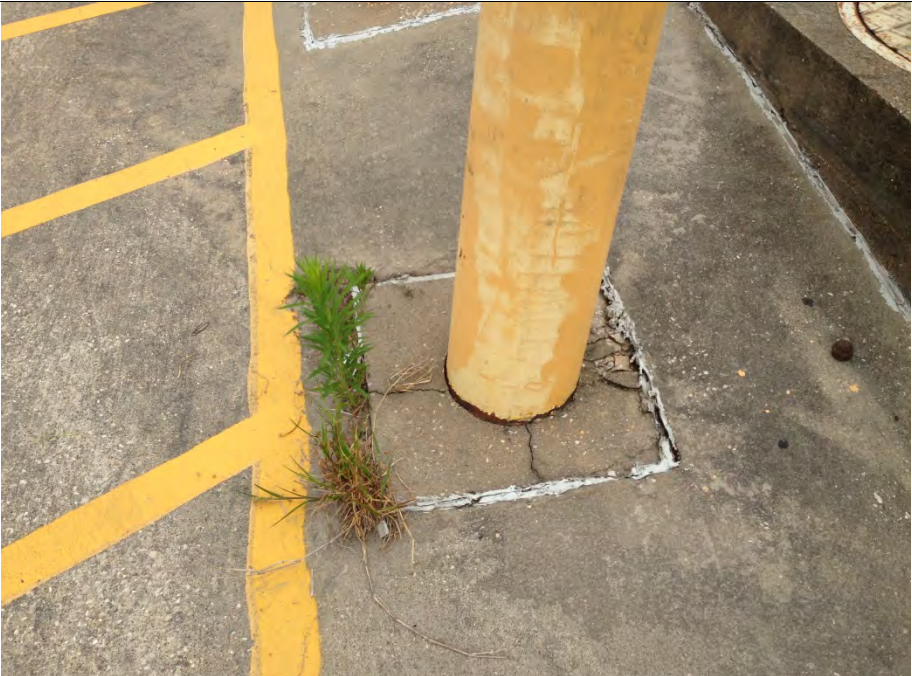
The condition of the concrete cap in both the Southeast and Southwest Areas is generally good and shows no change from the previous year. Other than a couple of locations in the Southwest Area (as shown on the attached photos) and around bollards and posts, there is no significant cracking or spalling other than the cracking that typically occurs as concrete cures. It should be noted that cracking, spalling and joint separation are occurring in areas outside the cap (see Photographs 15, 35 and 37). The edges of the cap are not currently affected.

<b>SITE PHOTOGRAPH 15</b>	<b>South Cavalcade Site – Beazer East, Inc. Houston, Texas May 22, 2013</b>
<b>Direction Photo Taken:</b>  South  <b>Description:</b>  Southwest Area  East edge.

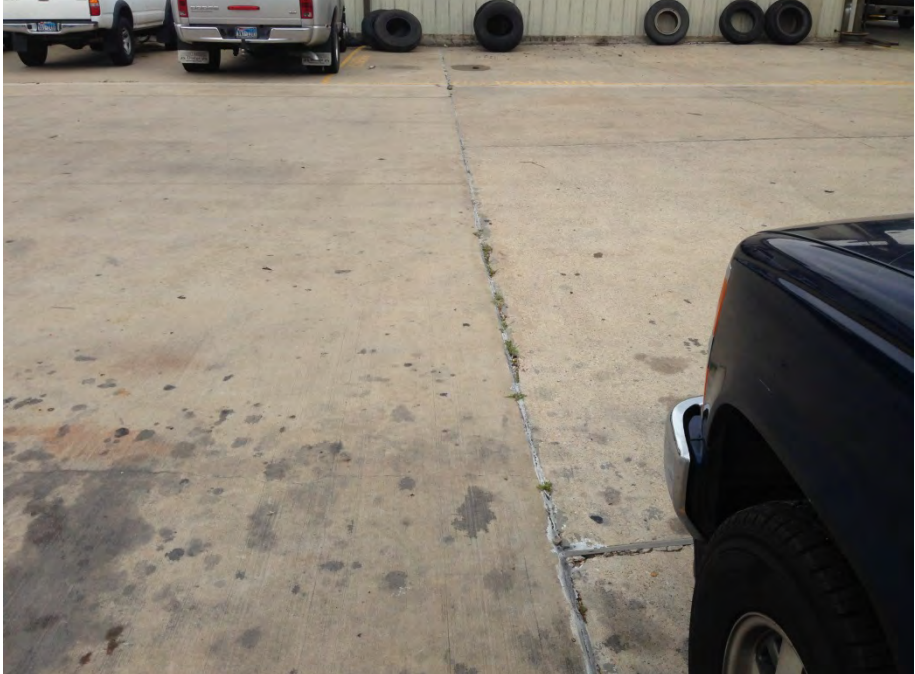
A new building was installed in August 2008 in the Southeast Area and an additional building was installed in 2009 (approximate locations shown in Figure 1). Inspection of the cap adjacent to the buildings indicated the cap was in good structural condition (see Photographs 18, 20 to 23, 39, and 42). Observable pipe cut repairs were in good condition (see Photographs 41 and 42).

<b>SITE PHOTOGRAPH 18</b>	<p align="center"><b>South Cavalcade Site – Beazer East, Inc.</b>  <b>Houston, Texas</b>  <b>May 22, 2013</b></p>
<p><b>Direction Photo Taken:</b></p> <p>North</p> <p><b>Description:</b></p> <p>Southeast Area</p> <p>South end of cap.  View of 2008 building.  2009 building seen  behind first building.</p>

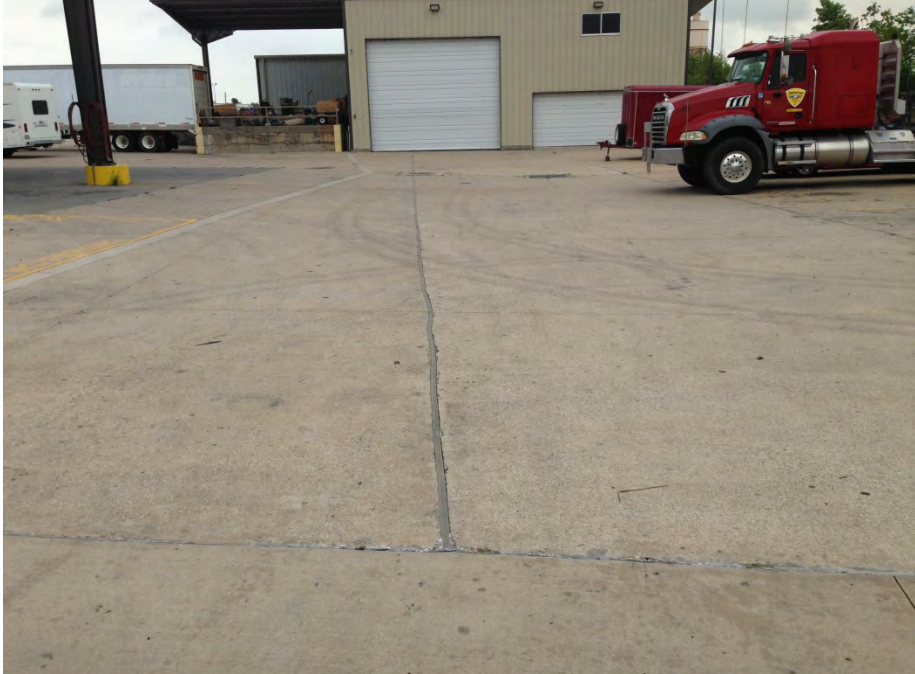
<p><b>SITE PHOTOGRAPH 19</b></p>	<p><b>South Cavalcade Site – Beazer East, Inc. Houston, Texas May 22, 2013</b></p>
<p><b>Direction Photo Taken:</b></p> <p>North</p> <p><b>Description:</b></p> <p>Southeast Area</p> <p>East edge of cap and property.</p> <p>Some chipping along edge, no change in condition.</p>

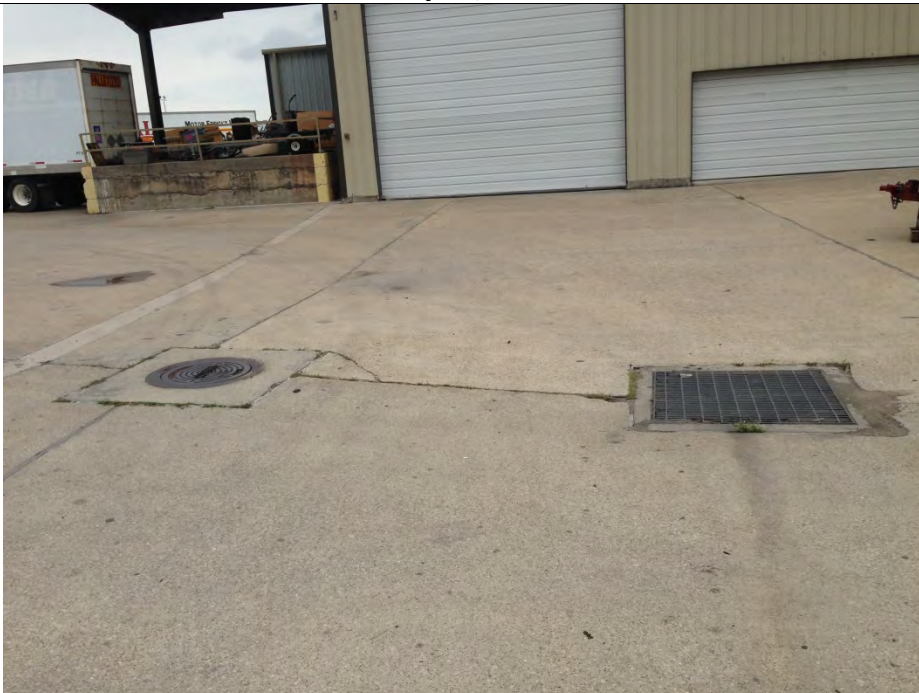
<b>SITE PHOTOGRAPH 21</b>	<b>South Cavalcade Site – Beazer East, Inc. Houston, Texas May 22, 2013</b>
<p><b>Direction Photo Taken:</b></p> <p>North</p> <p><b>Description:</b></p> <p>Southeast Area.</p> <p>Between loading dock and 2008 building. Cap integrity intact.</p>

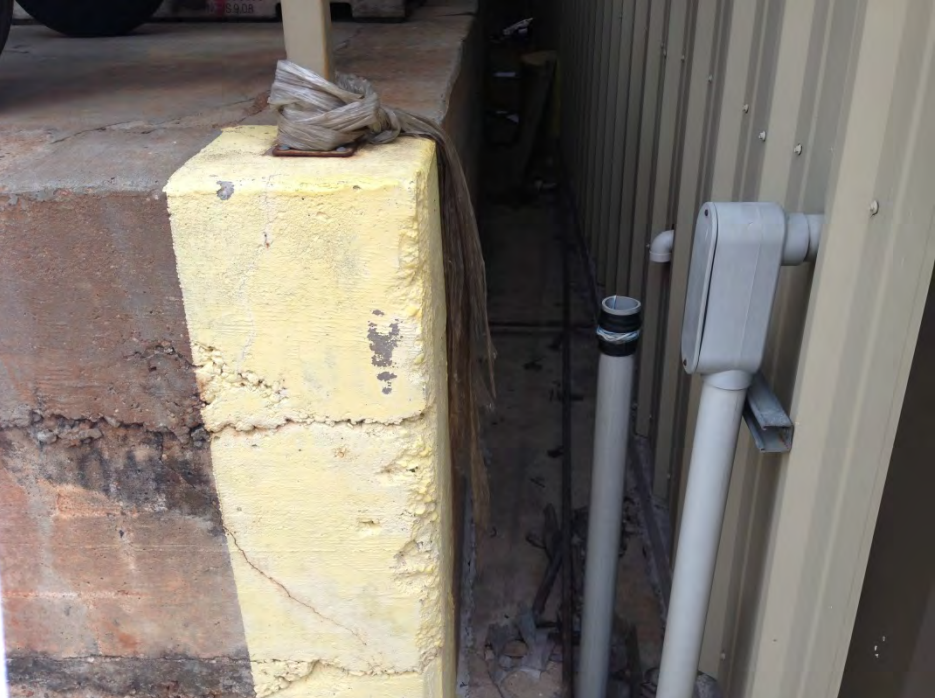
<b>SITE PHOTOGRAPH 22</b>	<b>South Cavalcade Site – Beazer East, Inc. Houston, Texas May 22, 2013</b>
<p><b>Direction Photo Taken:</b></p> <p>Southwest</p> <p><b>Description:</b></p> <p>Southeast Area</p> <p>View of 2008 building on east side of cap.</p>

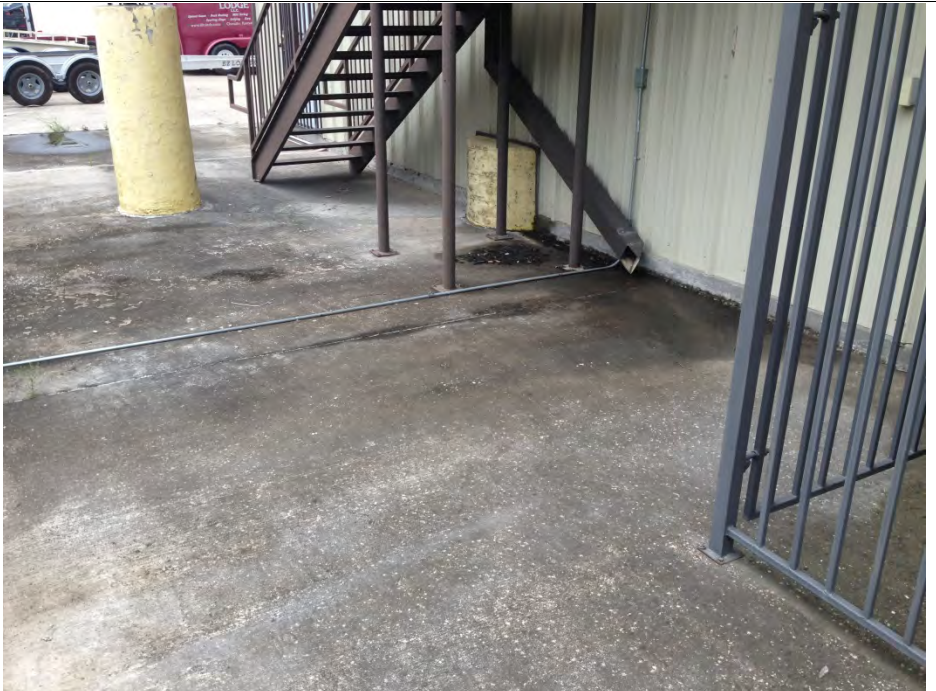
<b>SITE PHOTOGRAPH 23</b>	<b>South Cavalcade Site – Beazer East, Inc. Houston, Texas May 22, 2013</b>
<p><b>Direction Photo Taken:</b></p> <p>West</p> <p><b>Description:</b></p> <p>Southeast Area</p> <p>Elevation and slope transition. Area between elevated cap, 2009 building and 2008 building. Cap integrity intact.</p>

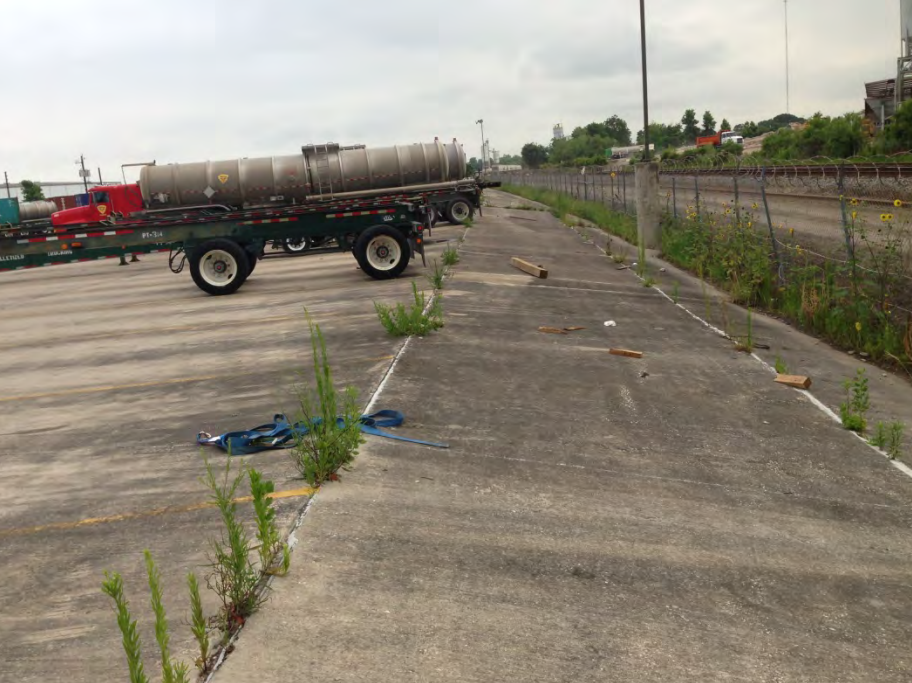
The ARCADIS 2007 thru 2012 reports noted two cracks in the Southeast Area cap that in reviewing the site as-builts fell outside of the impacted area. The condition of these cracks remains unchanged (Photographs 29 and 30). The cracks do not impact the effectiveness of the dermal barrier, however, minor repairs consisting of caulking should be considered.

<p><b>SITE PHOTOGRAPH 29</b></p>	<p><b>South Cavalcade Site – Beazer East, Inc. Houston, Texas May 22, 2013</b></p>
<p><b>Direction Photo Taken:</b></p> <p>East</p> <p><b>Description:</b></p> <p>Southeast Area</p> <p>Cracks in east slope. No change in condition from previous year.</p>

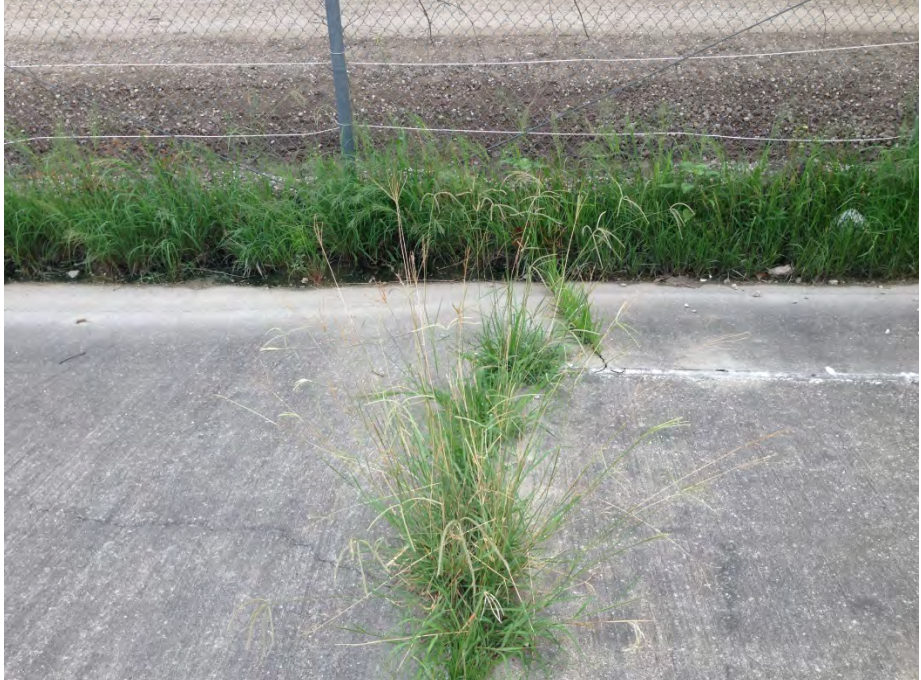
<p><b>SITE PHOTOGRAPH 30</b></p>	<p><b>South Cavalcade Site – Beazer East, Inc. Houston, Texas May 22, 2013</b></p>
<p><b>Direction Photo Taken:</b></p> <p>East</p> <p><b>Description:</b></p> <p>Southeast Area</p> <p>Cracks in the east slope need repair. (Same condition as previous years). Location is outside of impacted area. Other cracks along slope are starting to develop but no change observed from previous years.</p>

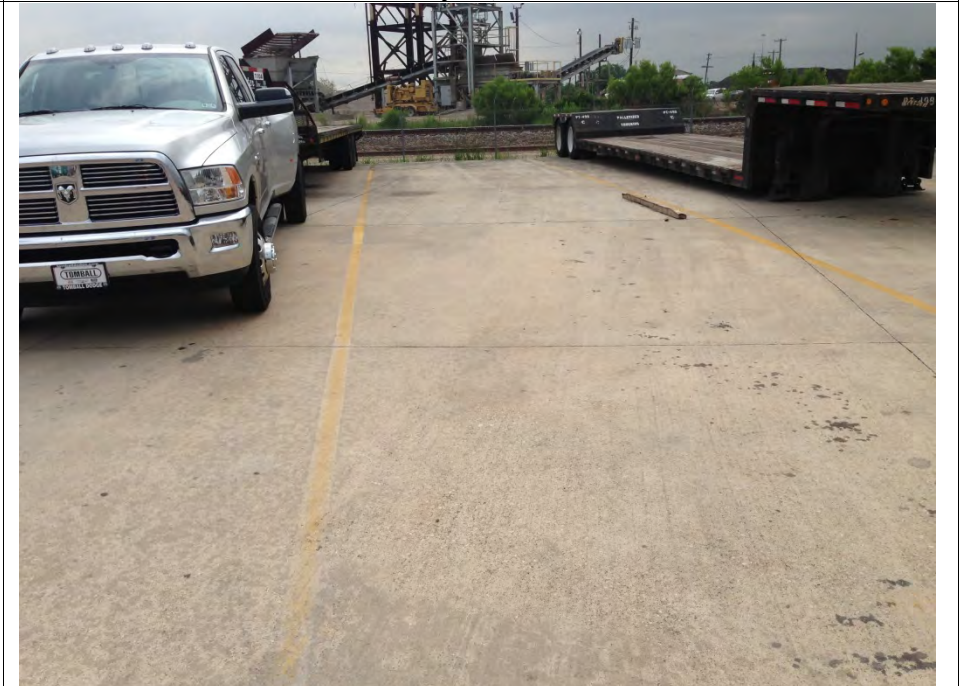
<b>SITE PHOTOGRAPH 35</b>	<b>South Cavalcade Site – Beazer East, Inc. Houston, Texas May 22, 2013</b>
<p><b>Direction Photo Taken:</b></p> <p>North</p> <p><b>Description:</b></p> <p>Southeast Area</p> <p>West edge of cap (Note that cracks in concrete are west of cap).</p>

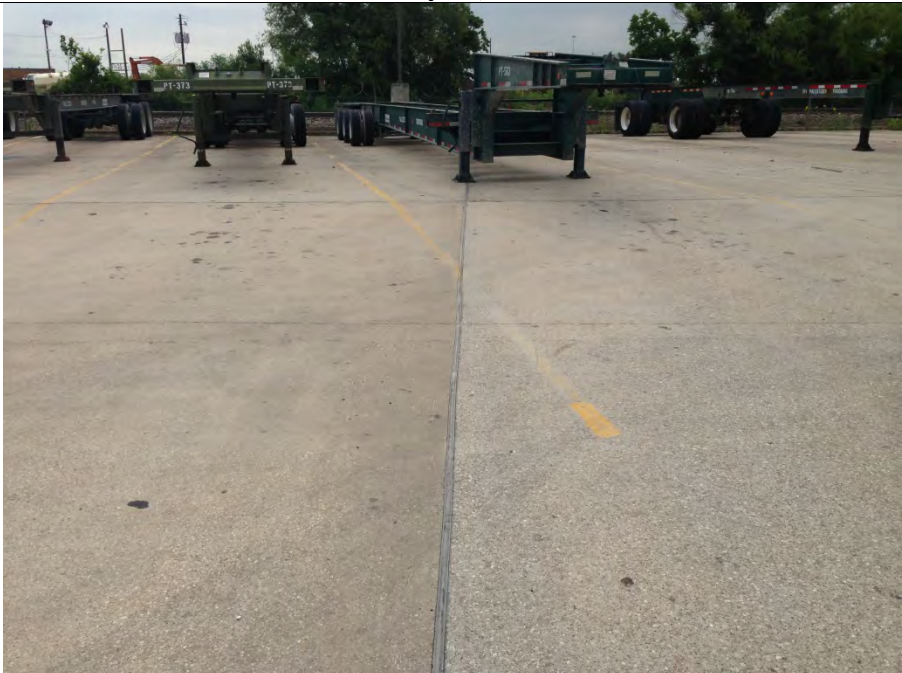
<b>SITE PHOTOGRAPH 37</b>	<b>South Cavalcade Site – Beazer East, Inc. Houston, Texas May 22, 2013</b>
<b>Direction Photo Taken:</b>  South  <b>Description:</b>  Southeast Area  West edge typical inlet.

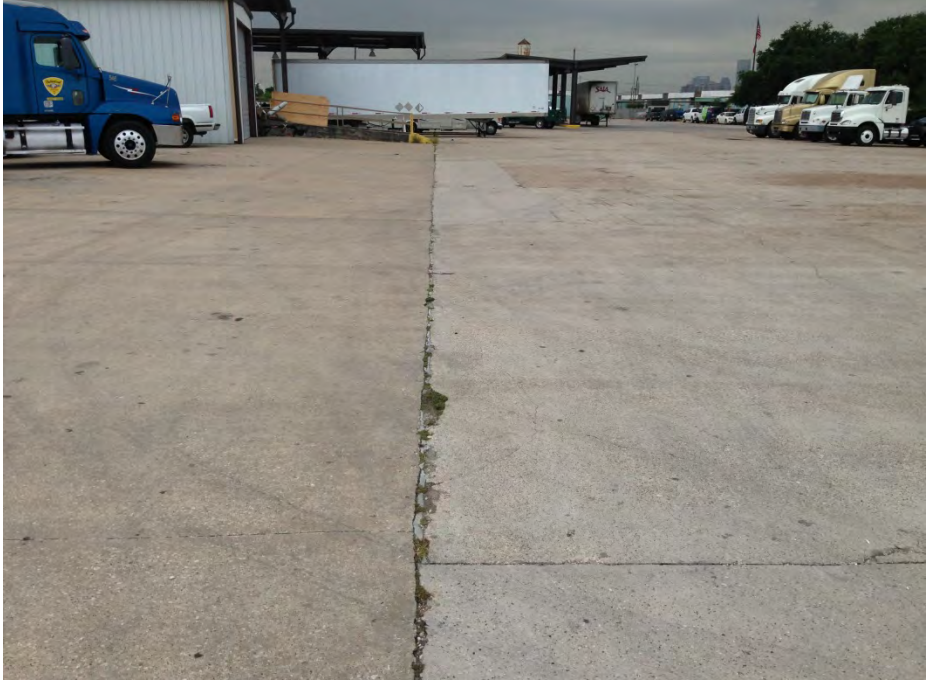
<b>SITE PHOTOGRAPH 39</b>	<b>South Cavalcade Site – Beazer East, Inc. Houston, Texas May 22, 2013</b>
<p><b>Direction Photo Taken:</b></p> <p>Southeast</p> <p><b>Description:</b></p> <p>Southeast Area</p> <p>Corner of west edge of cap and loading dock.</p>

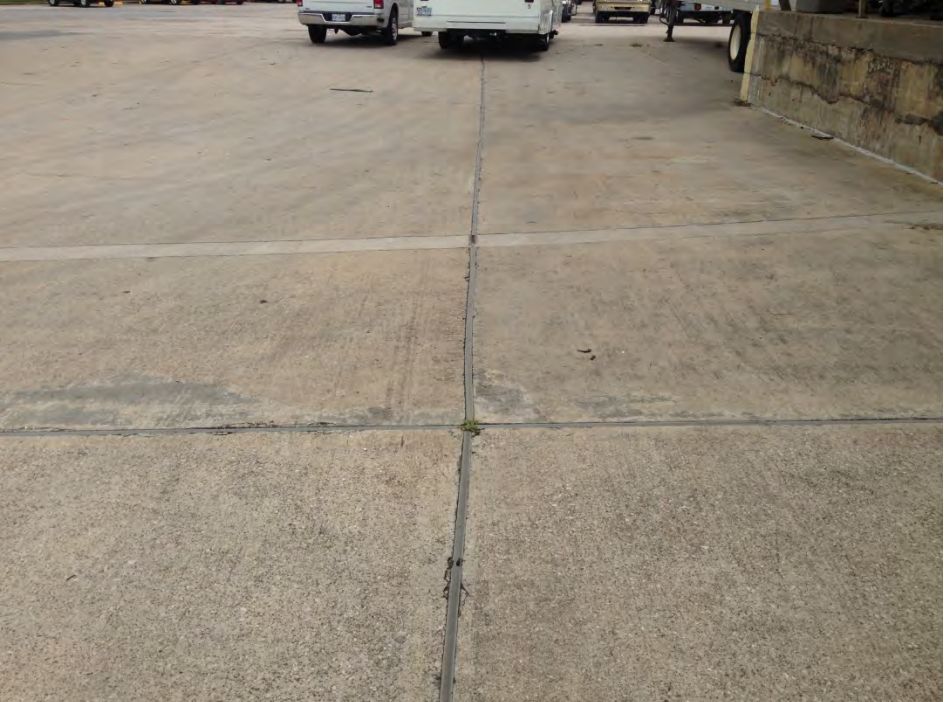
<b>SITE PHOTOGRAPH 42</b>	<p style="text-align: center;"><b>South Cavalcade Site – Beazer East, Inc.</b>  <b>Houston, Texas</b>  <b>May 22, 2013</b></p>
<p><b>Direction Photo Taken:</b></p> <p>North</p> <p><b>Description:</b></p> <p>Southeast Area</p> <p>View of pipe cut for 2008 building.</p>
